GENESIS

MISHAP INVESTIGATION BOARD REPORT VOLUME I

GENESIS MISHAP REPORT VOLUME I

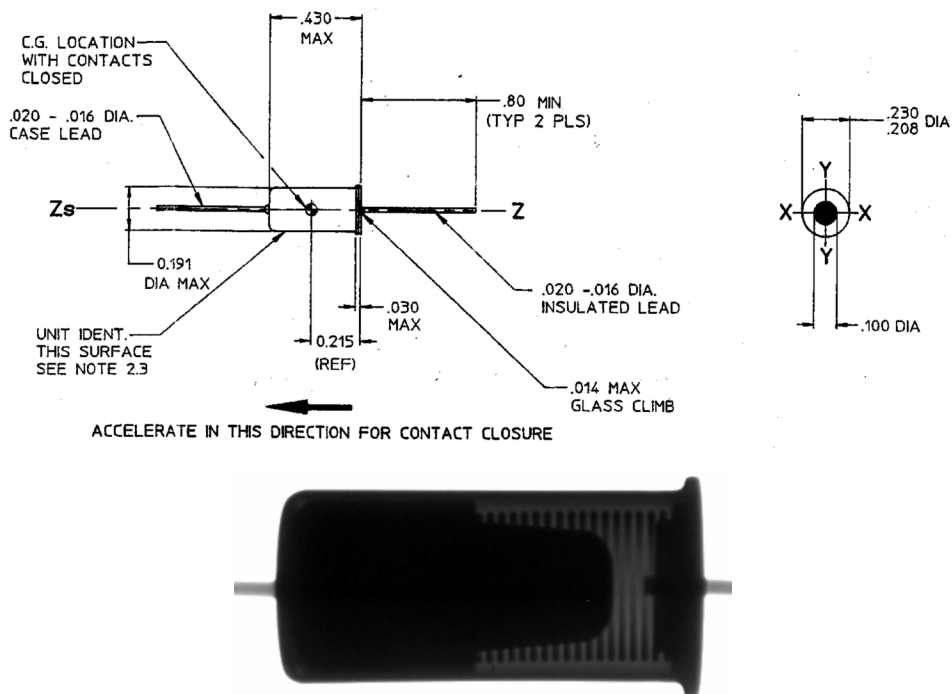
Figure 1.11.
Aerodyne 7200-6-000
acceleration switch
(G-switch sensor) drawing
and X-ray.

The G-switch sensor is an acceleration-sensitive sensor, which is somewhat smaller than the metal ferrule of a common wooden pencil (Fig. 1.11).

The acceleration direction required to close the switch is shown in Figure 1.11. An X-ray of the G-switch sensor shows how the spring mass and contact are oriented inside the cylinder (Fig. 1.11). The closure lip provides a good orientation reference between the photograph of the exterior and the X-ray of the interior of the G-switch sensor. When the G-switch sensor is mounted in the correct orientation, the internal plunger compresses against its spring as the g's are increased, making electrical contact. The g profile for the Genesis entry, shown in Figure 1.12, was close to the pre-launch prediction.

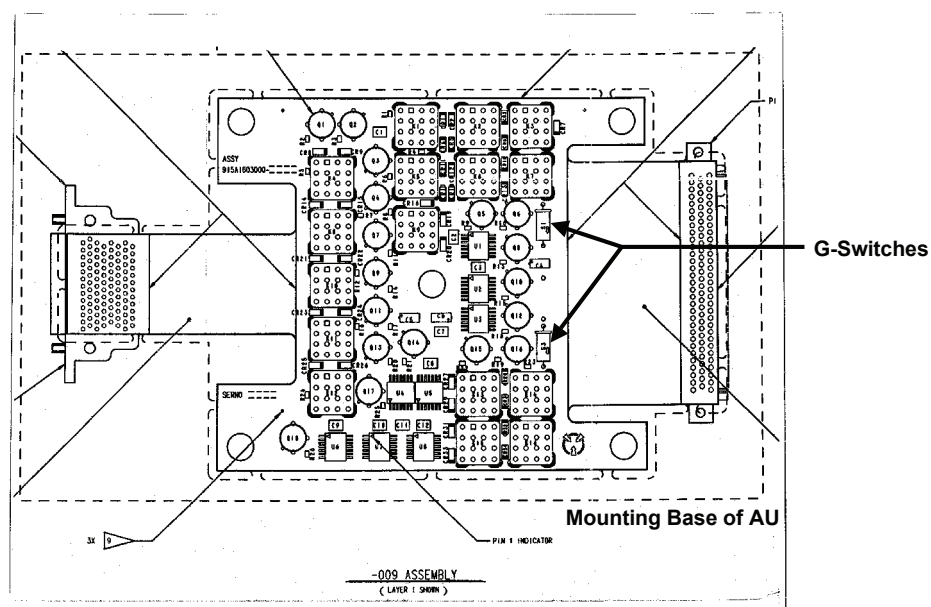
Figure 4.1.
Relay card
assembly drawing.

Figures 4.1 and 4.2 show an assembly drawing and close out photograph of a flight relay card with G-switch sensors, respectively.

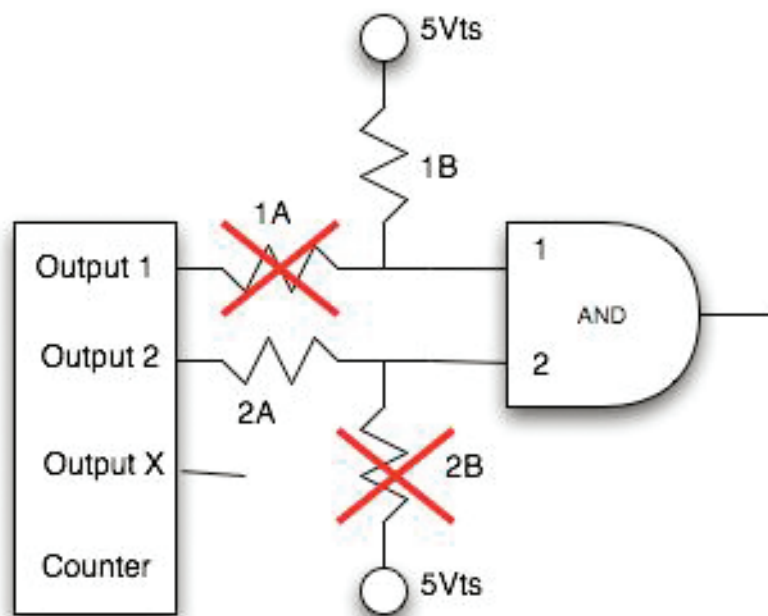
Figure 7.1.
Example of EST timing
circuit and timing jumper/
resistor placements.

The Avionics/Pyrotechnics/EEE Parts Subteam reviewed the base-lined drawings and subsequent changes, made with respect to the placement of the timing resistors and the respective signal timing expected from those resistor positions.

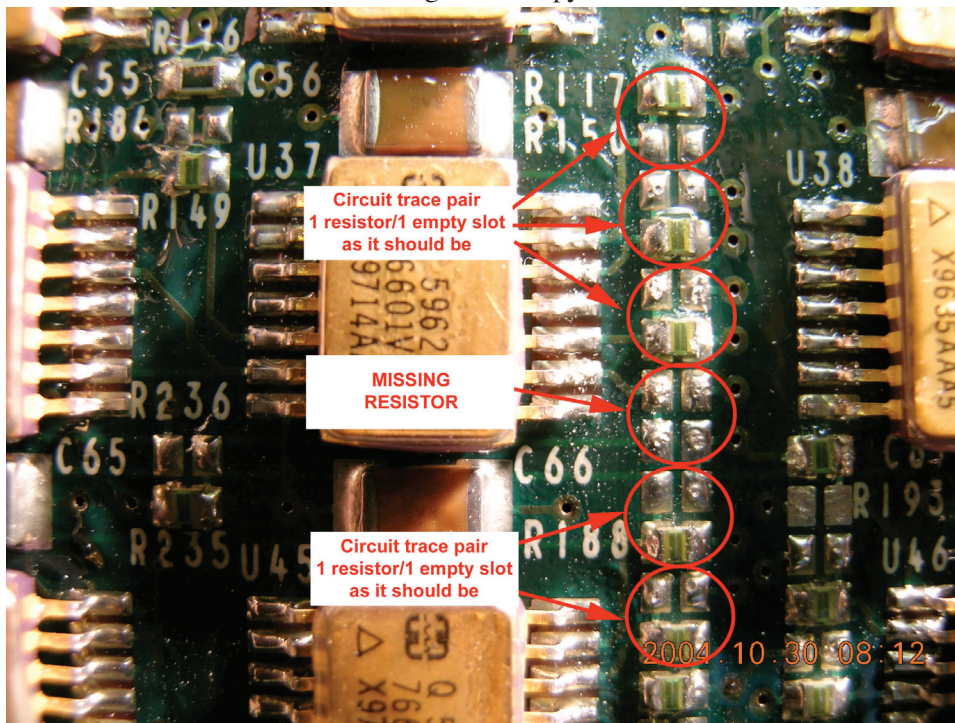
What this floating input means for the timing circuit is that if the input happened to 'float' to a logic '1' during the timing sequence, the circuit would have worked as expected. However, if the input 'floated' to a logic '0', that particular timing circuit would have failed to send a 'fire' signal to its pyro. Since there was a redundant

Figure 7.2
Example of resistor pairs and the intended location of the missing resistors.

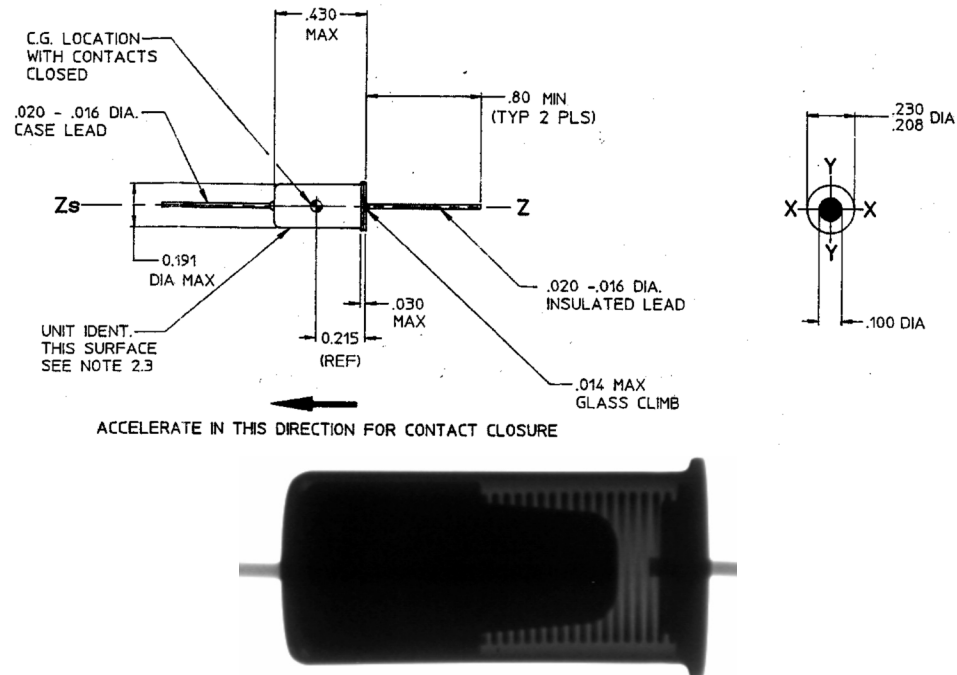
deceleration dropped below 3 g's as the capsule slowed, the plunger would have been pushed away from the contact, breaking the circuit and causing the EST to start, leading to the successive deployments of the drogue and parafoil.

Figure B-14.
Aerodyne 7200-6-000
acceleration switch
(G-switch sensor) drawing
and X-ray.

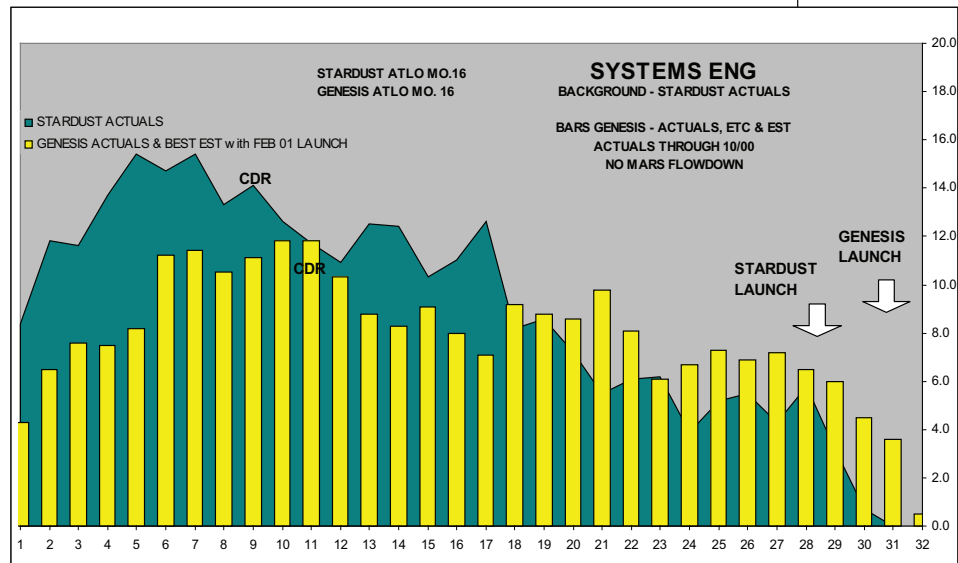
The MIB drew its conclusion that the LMSS staff was inadequate by considering that the LMSS Chief Systems Engineer held three positions (Chief Systems Engineer, Systems Engineering Manager, and Contamination Engineer). It became clear from interviews that the Systems Engineering team was hard pressed to meet their stated (although incomplete) obligations, much less the additional obligations that should have been assigned.

Figure E-1.
 Comparison of LMSS Stardust and Genesis Systems Engineering staffing profiles over project life. Genesis launch indicates planned launch; actual launch delayed late in life to accommodate Mars Odyssey needs.

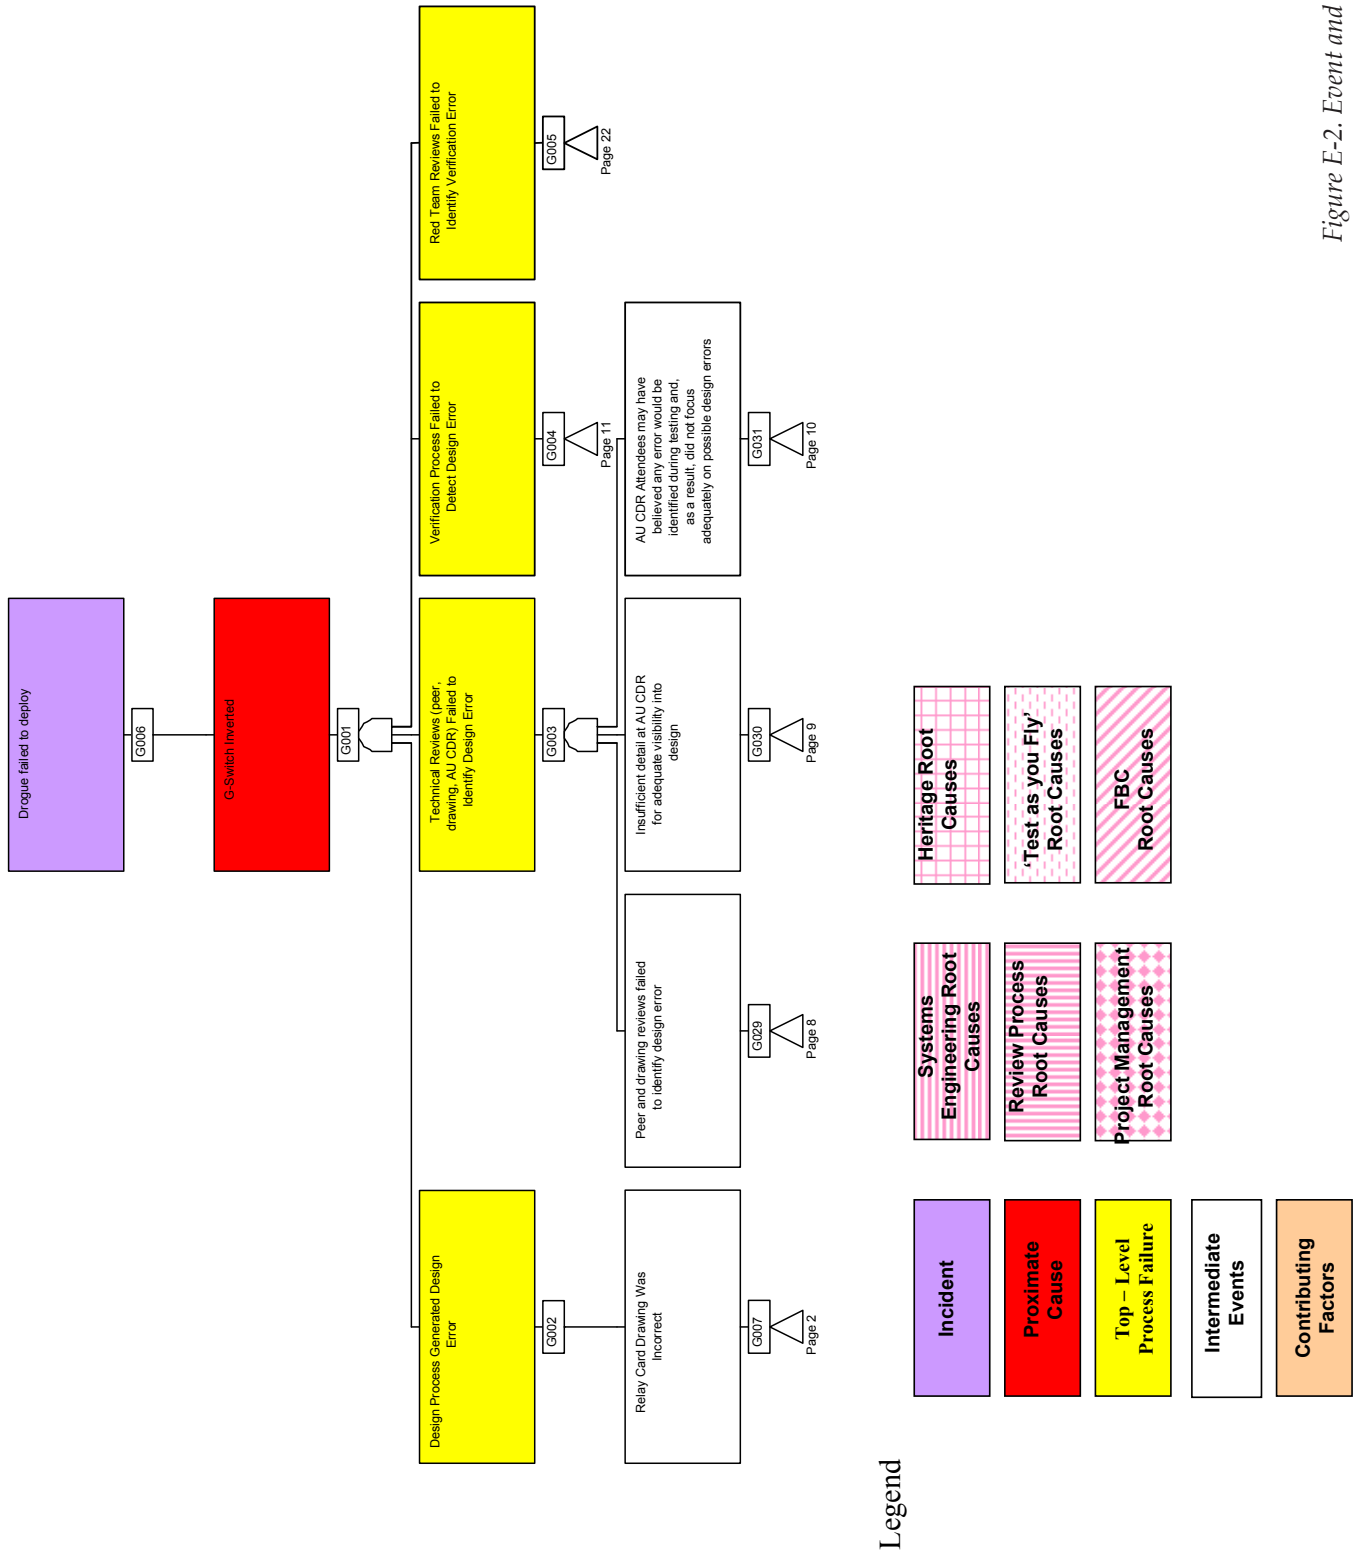
Figure E-2. Event and Causal Factor Tree.

NASA was also at fault for encouraging and accepting this concept. They selected this mission with only 11-percent budget reserve at confirmation and had only 7.2 percent at CDR. All involved (NASA, JPL, and LMSS) were convinced that because of the assumed heritage design, this was an acceptable position. However, once heritage was broken and design issues arose, and the limited reserves expended, there was only one place for funds to be found -- the contractor's profits. Eventually, JPL Project Management asked LMSS to give up fee to cover other non-LMSS risk issues and avoid a project overrun of the cost cap. Later, due to a launch slip and NASA-mandated changes the project obtained more money for the JPL Project Team; and was able to re-establish fee for LMSS through incentives to be efficient during flight operations.
